# EXPERIMENTAL INVESTIGATION ON GAS TURBINE BLADES FOR SELECTED MATERIALS UNDER DIFFERENT TESTING CONDITIONS

## **Abstract:**

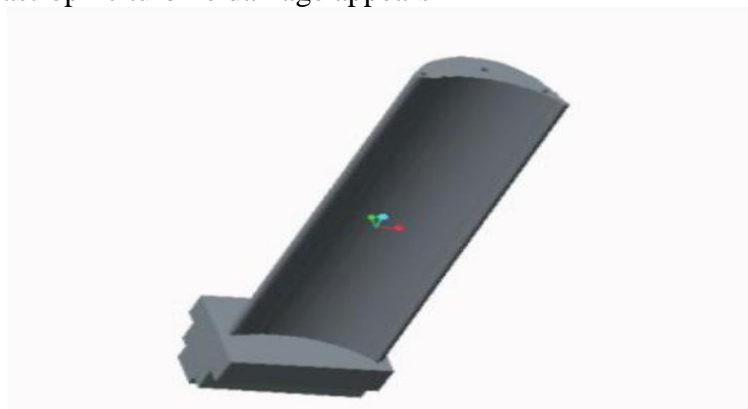
**Figure: Turbine blade model**

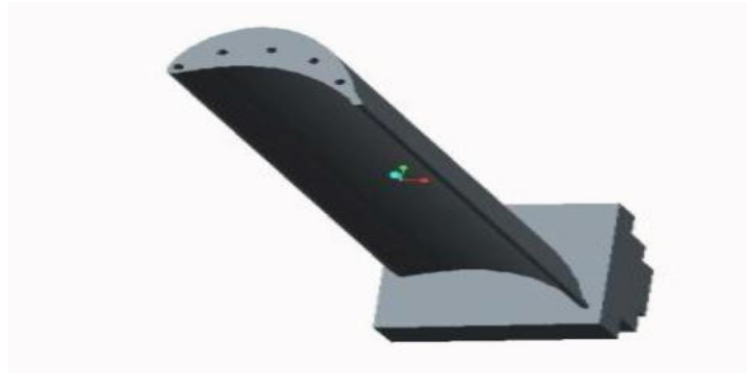
**Figure: Turbine blade isometric view**

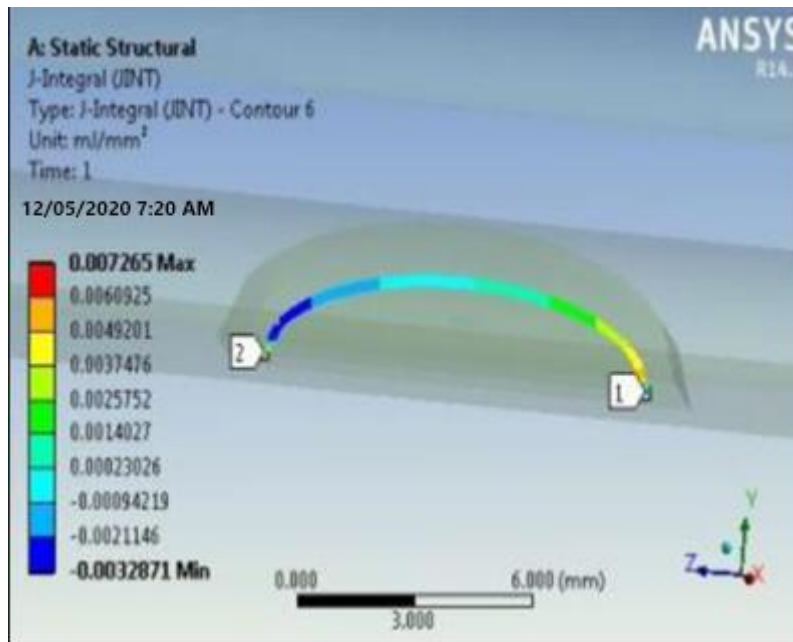
Figure: J-Integral

<b>MATERIAL</b>	<b>SIFS K1 (MPa.mm<sup>0.5</sup>)</b>	<b>SIFS K2 (MPa.mm<sup>0.5</sup>)</b>	<b>SIFS K3 (MPa.mm<sup>0.5</sup>)</b>	<b>JINT (mj/mm<sup>2</sup>)</b>
<b>SS+SIC(10%)</b>	23.711	17.576	19.478	0.0043697
<b>AL+SIC(10%)</b>	23.714	17.413	19.611	0.007265
<b>MS+SIC(10%)</b>	23.714	17.381	19.638	0.0042506
